AFRRI TR88-1

## TECHNICAL REPORT

### Cleanup of Johnston Atoll missile launch facility

B. E. Vesper  
M. Dooley  
T. H. Mohaupt  
E. T. Bramlitt

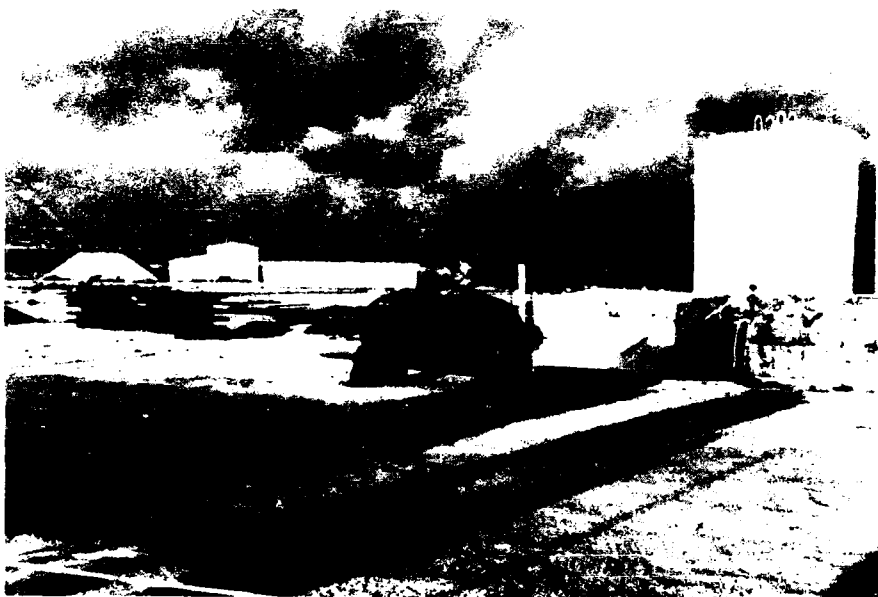
Figure 4. Below-grade liquid oxygen tanks and 28,000-gallon water tanks

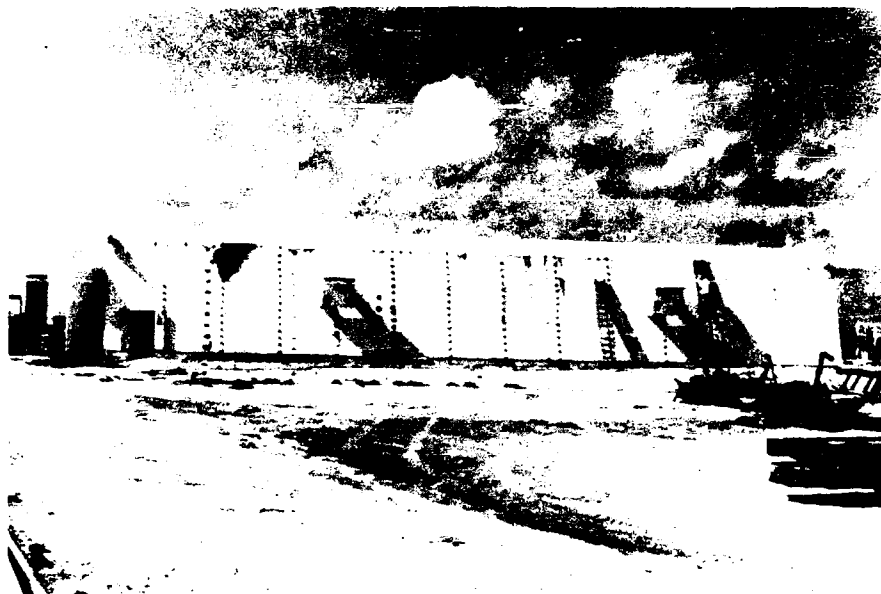
Figure 6. Missile shelter building before disassembly

To ensure that the nonsalvageable contaminated materials met the DoT and storage-site requirements, the structures on the Launch Emplacement Site 1 (excluding the concrete pads) were first disassembled and cut into workable sizes (Figures 6 and 7). When possible, the debris was cut into pieces about 6 feet by 8 feet to conserve space in the freight containers. Because there were so many different types of debris (pipes, cabling, ladders, railroad ties, etc.), the sizes of the cut pieces varied greatly. Each piece was then cleaned and painted. The debris was painted to effectively fix any remaining contamination in place, meeting the DoT requirement that there be no loose contaminants. The loose Gunit concrete could be broken up into workable pieces and processed in the same manner as the structural debris. However, it was not practical to remove the massive concrete pads. Instead, only the contaminated surfaces were removed through a process called scabbling, in which the top layers were chipped away. That material was then stored in 55-gallon drums. The scabbling process, described below, resulted in rubble whose contamination was uniformly distributed. Before

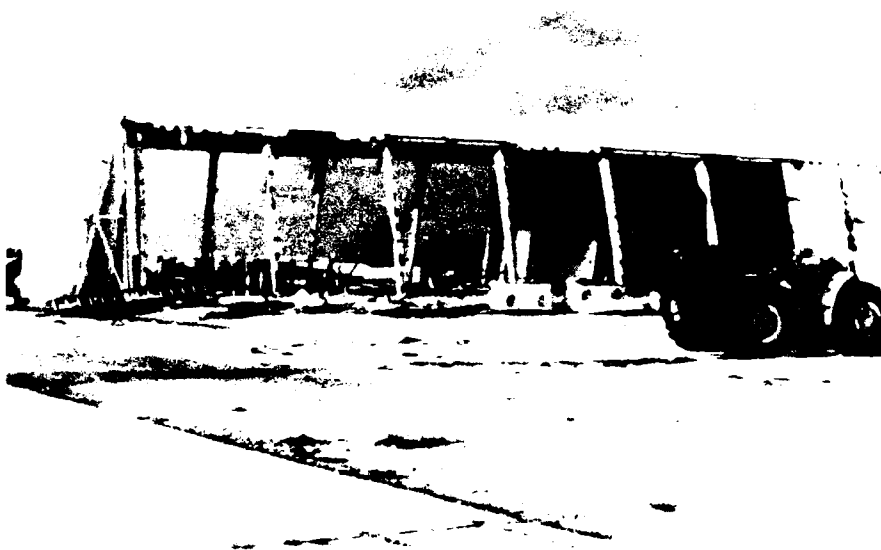
Figure 7. Missile shelter building with panels removed

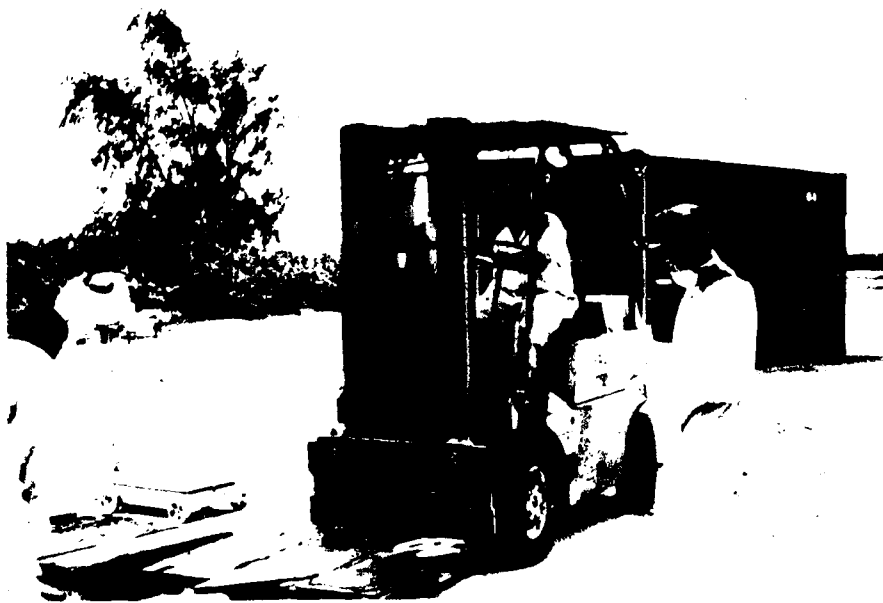
Figure 8. Debris being weighed before loaded into freight container at rear

Structural debris meeting the LSA criteria was loaded onto large (20 feet long by 8 feet wide by 9 feet high) dry-cargo freight containers (Figure 8), and the concrete rubble and any Type A material were loaded into 55-gallon drums. The freight containers were lined with plywood on each of the six surfaces to prevent puncturing of the walls, and were braced to prevent settling or rearrangement of the contents during shipment. These containers served as both package and transport vehicles for the bulk LSA material. One freight container was dedicated to the material packaged in the 55-gallon drums, and for these materials, the freight containers served only as the transport vehicle. Detailed records were kept of the material and the total amount of activity loaded into each container so as not to exceed the DoT or the Nevada Test Site criterion. The freight containers were shipped from Johnston Island to the Naval Construction Battalion Center in Port Hueneme, California, and then were transported by truck to the disposal site at the Nevada Test Site.

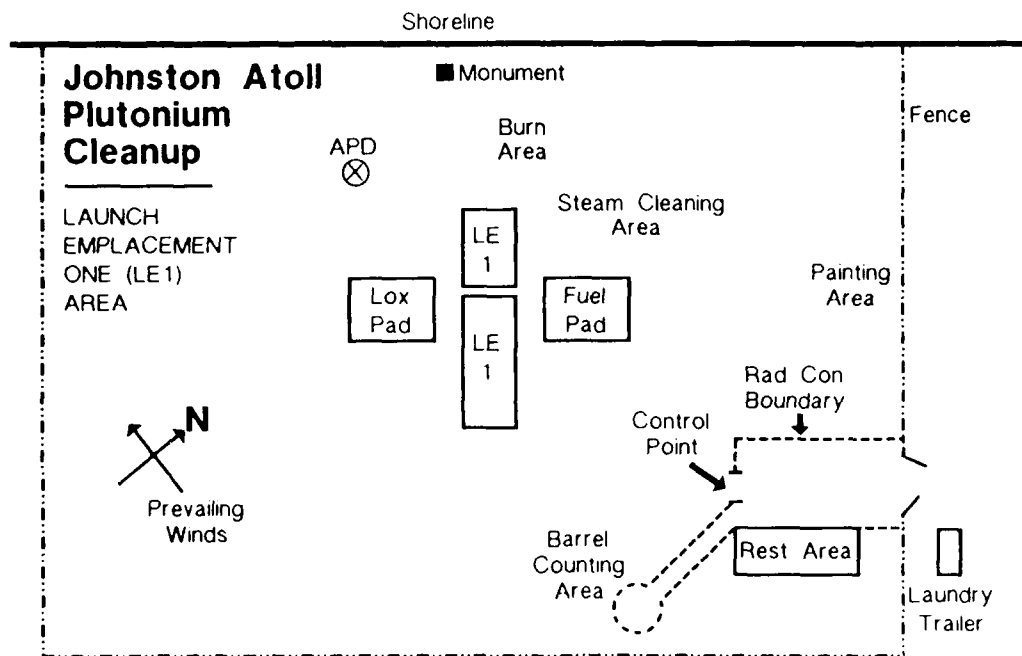
Figure 9. Layout of cleanup site

The missile launch facility was located on the northern shore of Johnston Island, the main island of the atoll. Prevailing winds blew from east to west; residential and most work areas on the island were upwind from the launch site (Figure 9). The layout of the site was organized to establish an efficient flow pattern for the removal of the contaminated materials. The different processing stations were arranged so that they were crosswind of each other. The break area, storage shed, and laundry trailer were all upwind of the contaminated area; a road barrier and open water were downwind of the site.

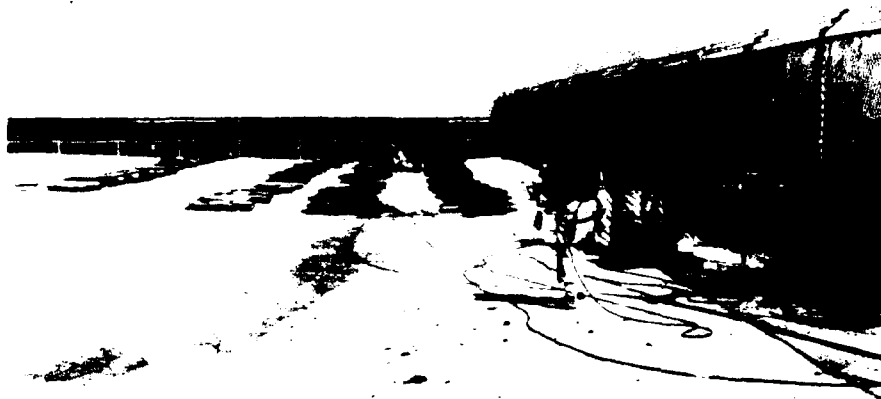
Figure 10. Debris paint area to fix contamination before monitoring

The first step in the removal process was to reduce the materials to workable sizes. The debris was cut into smaller pieces using acetylene torches, saws, and chipping hammers. After the materials were cut, they were either steam cleaned or rinsed with a high-pressure water hose to remove any loosely bound contaminant, paint, or dirt. The material was then loaded onto a clean pallet and moved to the painting area. At this station, any remaining contamination was fixed in place with a thick coating of black piling paint or white or yellow road-striping paint (which was outdated and not suitable for road use) (Figure 10). After all the exposed surfaces were painted, the materials were sent to the exit hot line for delivery by forklift to the counting site (Figure 11). Before leaving the contaminated area, the debris was smear-monitored to check for loose contamination.

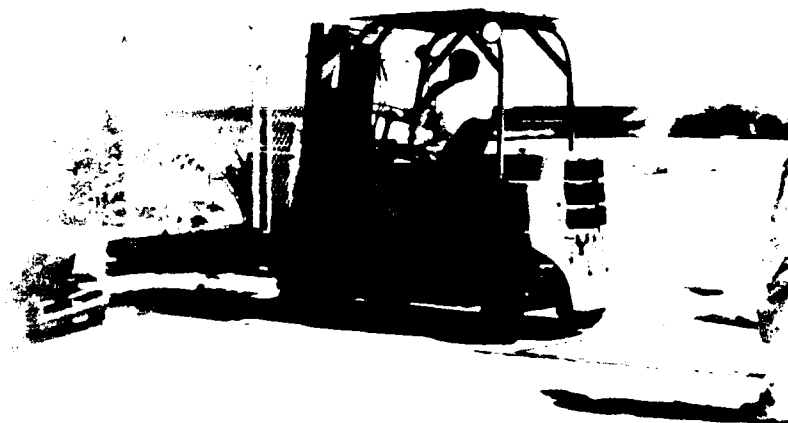
Figure 11. Transporting painted debris from paint area to counting pad

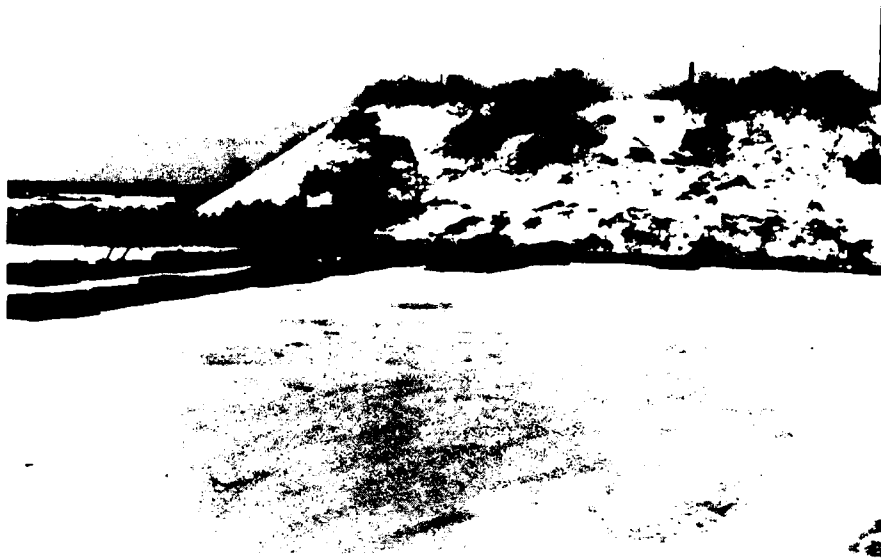
Figure 12. Debris laid out in rows at counting area

The counting area was about 800 feet east of the launch site and was chosen for its relatively low background radiation. When the pallets reached the counting area, they were laid out in rows (Figure 12), and each piece of debris was numbered (Figure 13). To locate areas with high levels of contamination, a preliminary

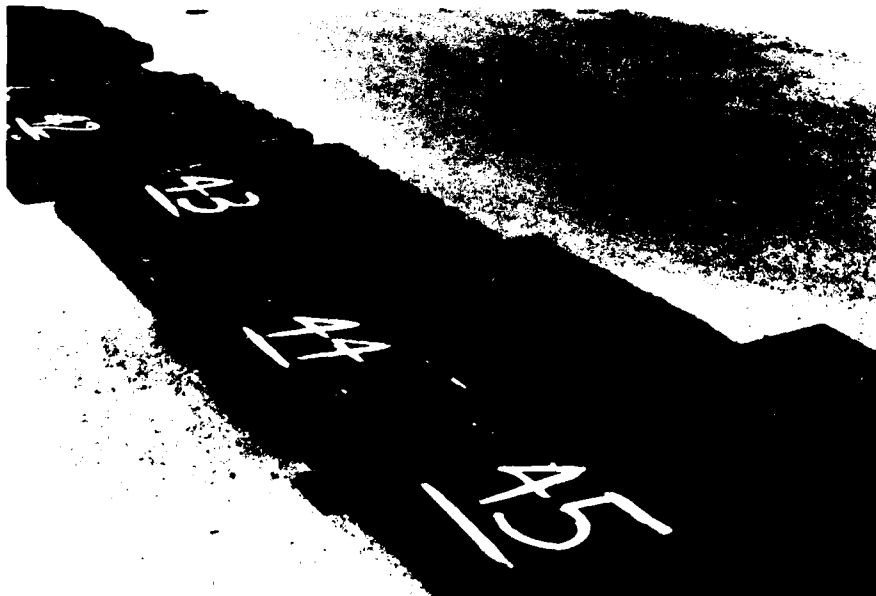
Figure 13. Numbers painted on each pallet of debris for identification

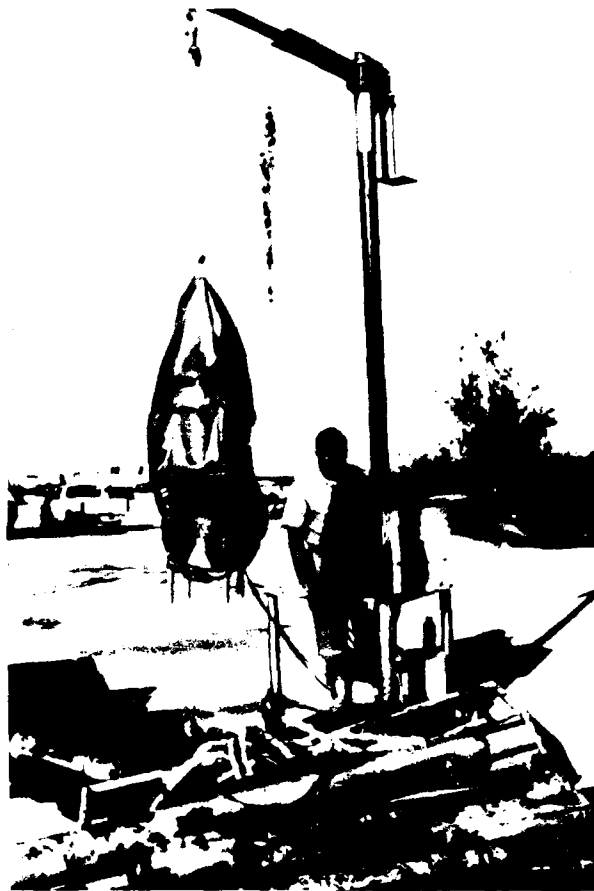
Figure 14. Monitoring pallet of debris with germanium detector system

survey was performed over the surface of each piece with a modified FIDLER (field instrument for detection of low-energy radiation). The FIDLER used for screening had a 2-inch-diameter sodium iodide crystal connected to an analog ratemeter and earphones, and the window was set to detect the 60-keV photons from the americium-241. When "hot spots" were located, they were marked with spray paint and counted separately. The activity on each piece (and hot spot) was measured using the germanium detector (Figure 14) or the backup sodium iodide detector. The counting system is discussed in detail below.

The detector was placed above the center of a piece of debris so that the field of view covered the longest dimension. If this was not possible, either the piece was cut into smaller sections or more than one count was made. When a hot spot was indicated on the debris, the detector was placed above the hot spot so that the field of view encompassed one square meter with the hot spot in the middle. Each piece was counted for 2 minutes, and the material identification number, peak display, and net area counts were recorded on multichannel analyzer minicassette tapes. The taped data were later input and stored along with the packaging data in a Compaq Plus (Houston, TX) computer.
